Manhole Inspection Summary

Manhole # S3501_001MH

Insp Date: **2/8/08 1:12 PM**

Location Address: **201 Reedbird Ave**

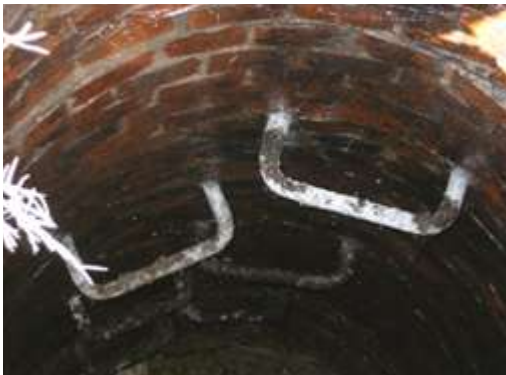
Steps Count: **7** Missing: **0** ☒ **Corroded**

steps

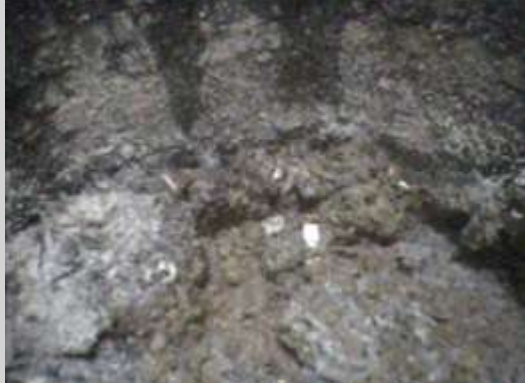
12 O'Clock Outflow

Comments **Effluent pipe @ 12 O'clock could not be measured due to excessive debris.**

12 in. Circular Gravity Sewer
Pipe Out @ 12 O'Clock

Pipe Height: **3.6** (in.) Rod and Bar (Angled)
Pipe Material: **Clay** ☐ Pipe Lined
Invert Depth: **1.00** (ft.) Flow Characteristics: **None**
Deposits: ☐ None ☐ Mud ☒ **Sludgy** ☐ Debris ☐ Grease
Silt Depth: **8** (in.) Deposits Extent: **Heavy**
Infiltration: **None** Pipe Seal Cond: **Unknown**

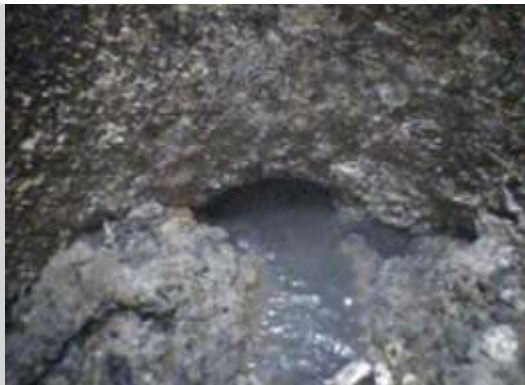
6 O'Clock Inflow

12 in. Circular Gravity Sewer
Pipe In @ 6 O'Clock

Pipe Height: **14.4** (in.) Rod and Bar (Angled)
Pipe Material: **Clay** ☐ Pipe Lined
Invert Depth: **14.28** (ft.) Flow Characteristics: **Slow**
Deposits: ☐ None ☐ Mud ☒ **Sludgy** ☐ Debris ☐ Grease
Silt Depth: **2** (in.) Deposits Extent: **Medium**
Infiltration: **None** Pipe Seal Cond: **Sound**
